# LEGIONELLA

## RISK ASSESSMENT

## Jubilee Building

**DATE : 10.03.22**

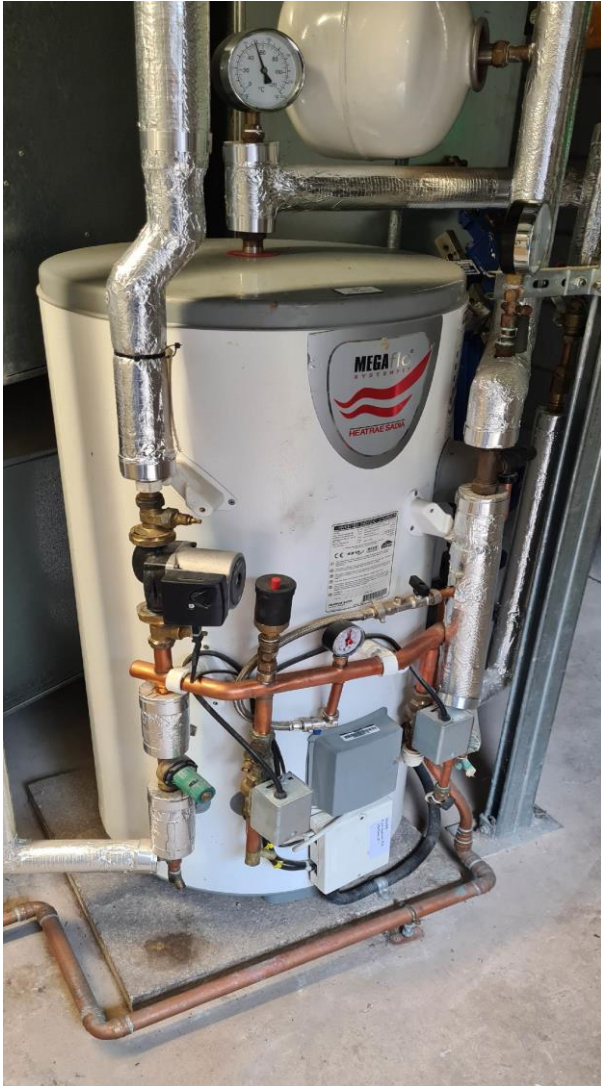
**Jubilee Calorifier**

The calorifier is in very good condition.
