# LEGIONELLA

## RISK ASSESSMENT

## POOL

**DATE : 10.03.22**

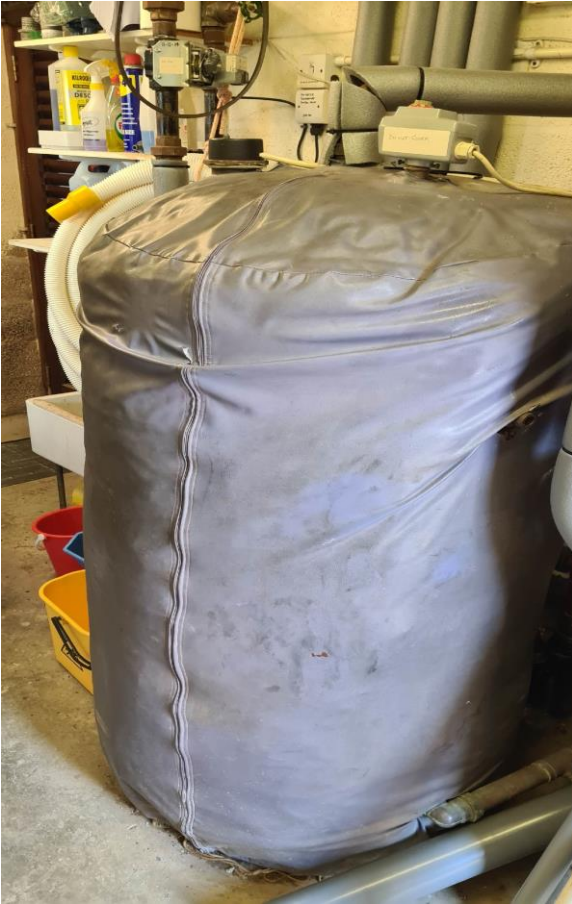
**Pool Calorifier**

The calorifier is in very good condition.
