# LEGIONELLA

## RISK ASSESSMENT

### The Warren

**DATE : 10.03.22**

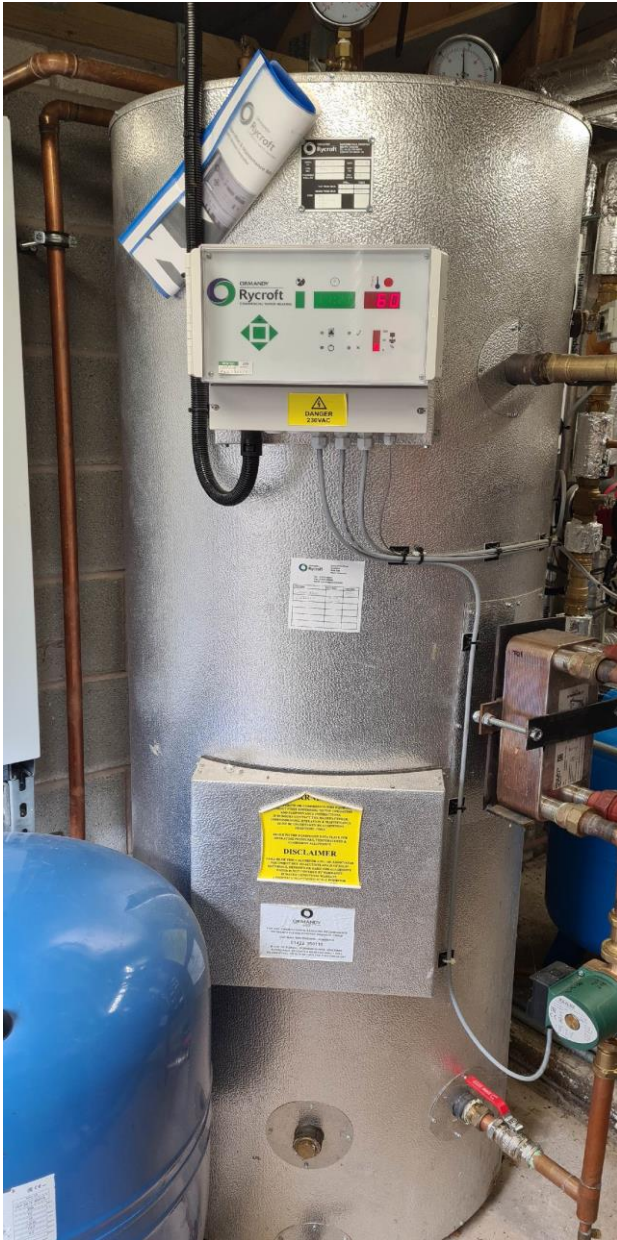
The calorifier is in very good condition.

**Calorifier**
