# LEGIONELLA

## RISK ASSESSMENT

### West End

DATE : 10.03.22

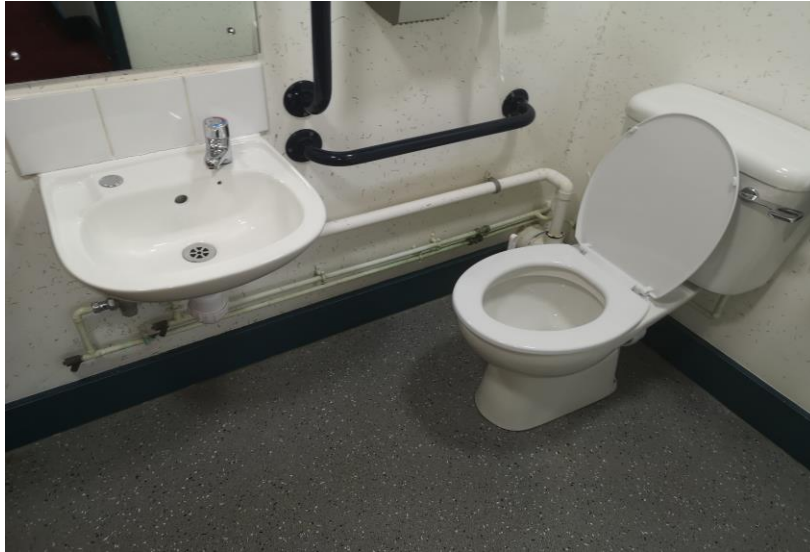
**Disabled Toilet TMV**

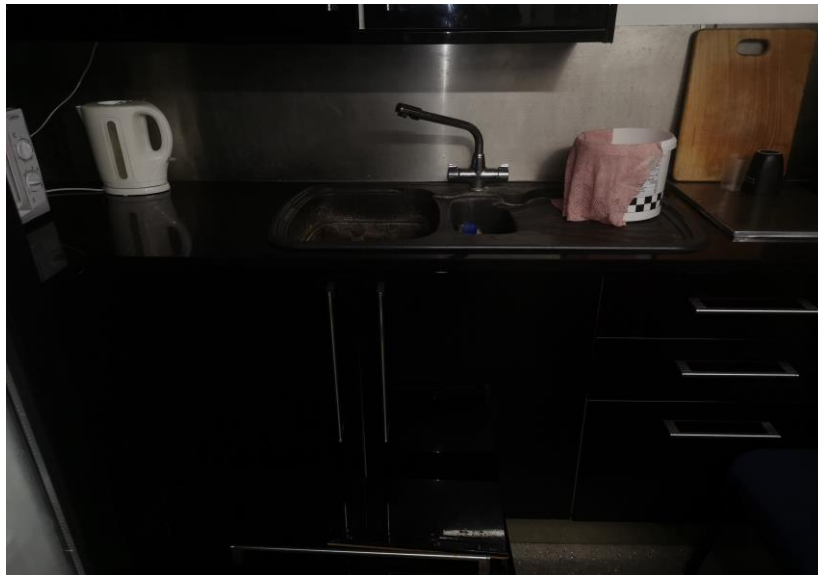
**Kitchen**
